TECHNICAL REPORT ARCCB-TR-98014

**FAILURE ANALYSIS OF AN 84-MM, M3,
CARL GUSTAF, RECOILLESS RIFLE**

JULY 1998

**US ARMY ARMAMENT RESEARCH,
DEVELOPMENT AND ENGINEERING CENTER
CLOSE COMBAT ARMAMENTS CENTER
BENÉT LABORATORIES
WATERVLIET, N.Y. 12189-4050**

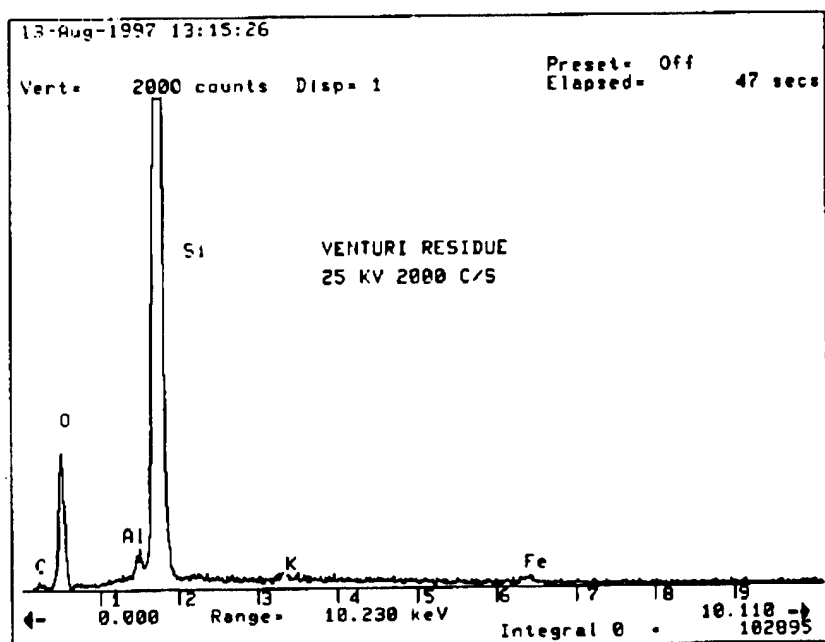
FIG.#1

Particles were also extracted from the venturi. Figure 1 shows these venturi particles to be equiaxed (as opposed to film-like), while EDX Figures 1A and 1B show them to be rich in Si. Figure 1A is consistent with silica, and Figure 1B is consistent with silicate. Silica (SiO_2) occurs widely in nature as sand, diatomite, quartz, flint, etc. Silicates are any of the widely occurring compounds of Si, O, and one or more metals, with or without hydrogen. Typical natural silicates are gem stones (except diamond), beryl, asbestos, clay, talc, feldspar, etc. There are also several types of clays (e.g., hydrated aluminum silicate) that are found in soils in varying percentages. Figure 1B is qualitatively consistent with feldspar (a potassium aluminosilicate). The hardnesses of silica (quartz) and feldspar are 820 and 560 Knoop (100 g load), respectively (ref A-1). If the conversions are correct at this low load, this is approximately 59 and 47 R_c , respectively. Both of these are harder than the metal rifle liner, which is approximately 28 to 32 R_c . The hardness of all types of clay could not be ascertained, but those that were found are softer than silica and/or feldspar. Silica melts at 1986 K—approximately 1000 lower than the reported gas temperatures in the rifle bore. Because they are softer, the melting point of feldspar and clay is probably lower than silica. The melting point of the debris may be important because much of the material found in the bore resembles a smeared film (as opposed to equiaxed particles).

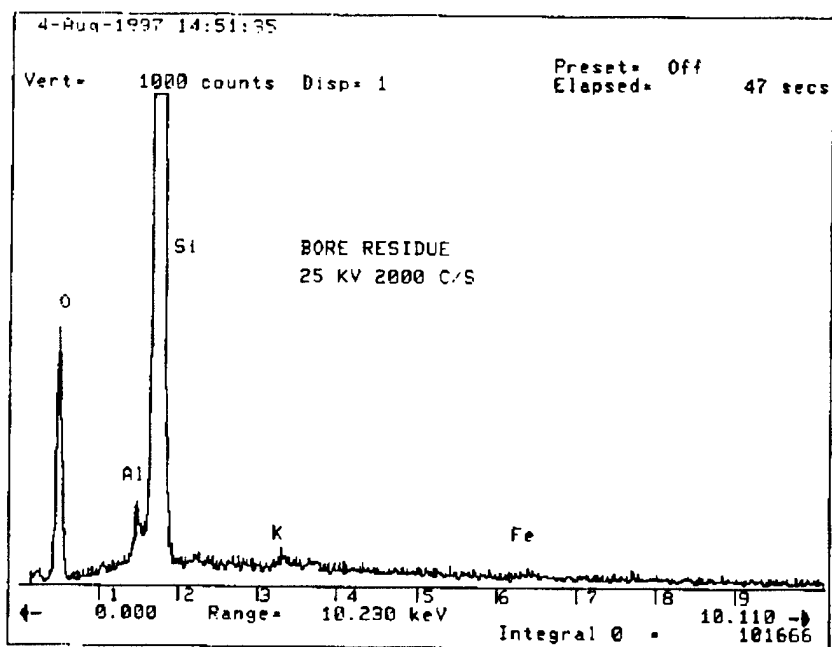
FIG. #4

Figures 4 through 4D are from particles that were extracted from the liner on the breech side of the crack. This area displayed a reddish appearance. Figure 4 shows a land/groove junction, while Figures 4A and 4B are Si and Fe maps, respectively, from this same area. The pictures show that large, equiaxed, Si-rich particles were concentrated in the

land/groove junction, while finer, thinner, Fe-rich material was present on the land. EDX spectra (shown in Figures 4C and 4D) indicate that the large particles are consistent with silica; the finer particles are probably iron oxide.

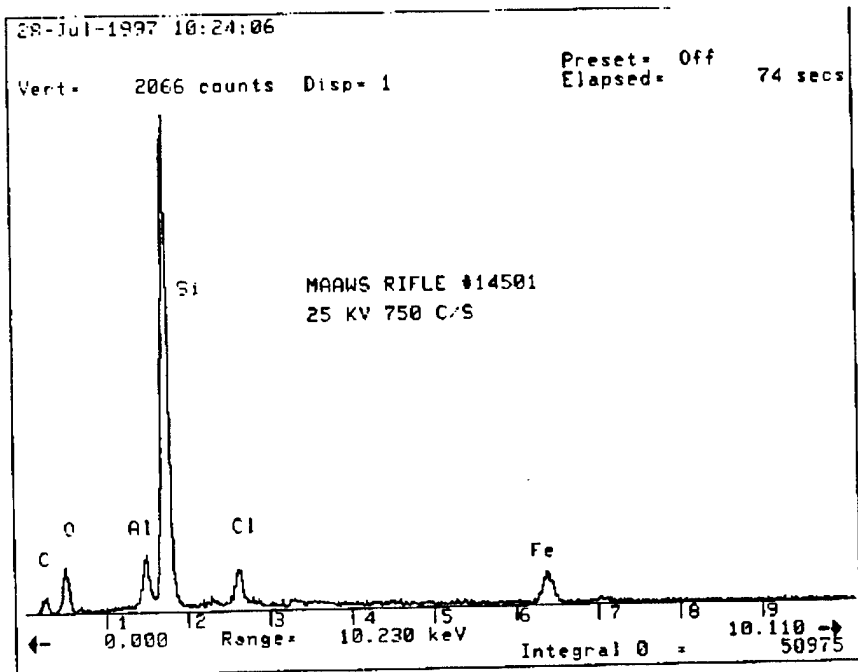
FIG. #5

3. The cracks on the composite outer diameter and the liner inner diameter were protected with plastic tape while the liner crack was cut to fit into the SEM. (During this cutting, the composite delaminated from the liner.) Figures 5 and 5A show a portion of the liner crack after sectioning. Figure 5 shows debris *in* the crack, while Figure 5A shows the debris to be rich in Si. The crack showed no evidence of brittle fracture.

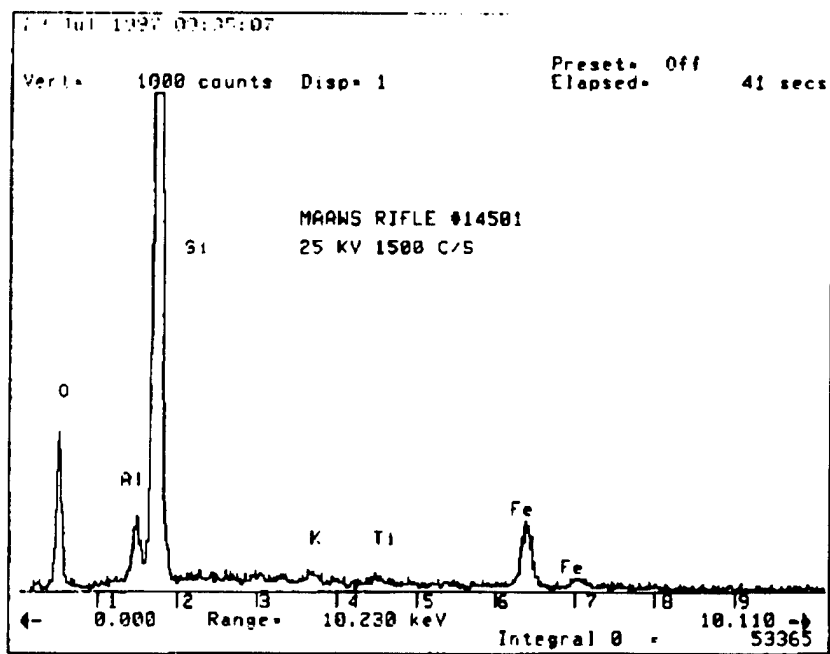
FIG. #6

4. The crack was then "broken open." Figure 6 shows a typical fracture surface (F), with debris still covering much of the separation. This debris was consistent with silica (Figure 6A). The debris was removed via tape to reveal the fracture mode. Figure 7 shows a typical fracture surface (F), while higher magnification (Figure 8) shows the fracture mode to be shear, which is consistent with a single cycle, tensile overload.
